Manhole Inspection Summary

Manhole # S29K__066MH

Insp Date: **1/30/09 2:31 PM**

Location Address: **219 S.Fremont St.**

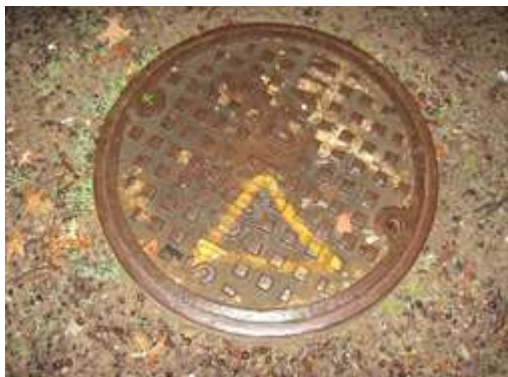
Miscellaneous

wrong lid

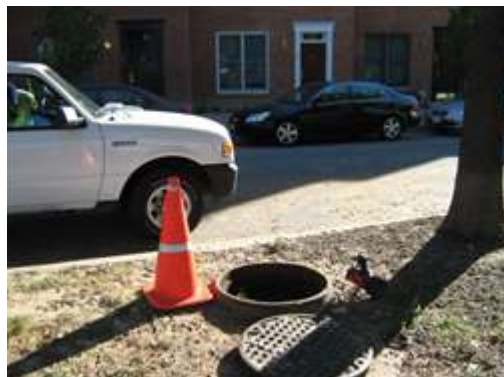
Miscellaneous

cover above grade ~3"

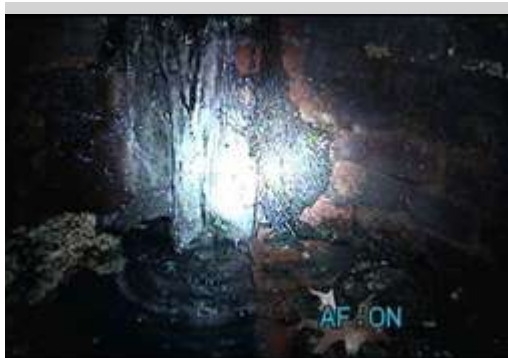
Defect 4

Condition: ☐ Sound ☐ Cracked ☒ **Root Intrusion** ☐ Loose Brick ☐ Deteriorated

☒ **Evidence Of Surcharge** Depth: **0.8** (ft.) ☒ **Active Surcharge Present**

surcharge evidence on barrel walls, roots in pipe connection

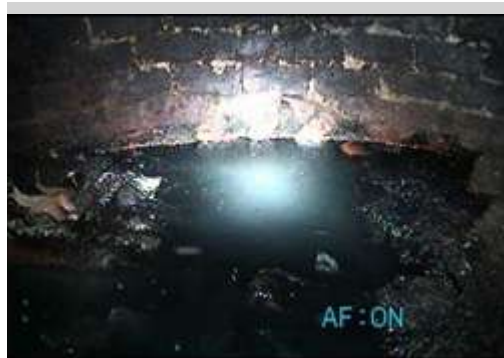
Defect 3

Condition: ☐ Sound ☐ Cracked ☐ Root Intrusion ☐ Deteriorated ☐ Leaks ☒ **Debris**

active surcharge, bench and channel debris

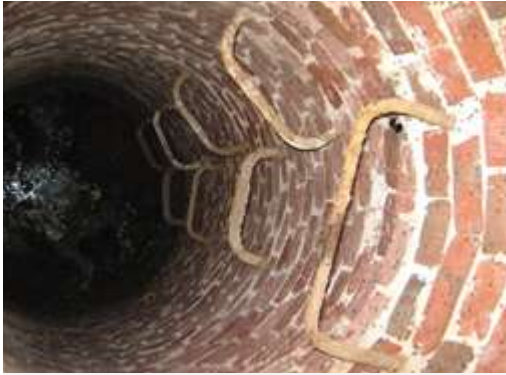
Defect 2

Count: **7** Missing: **0** ☒ **Corroded**

corroded rungs

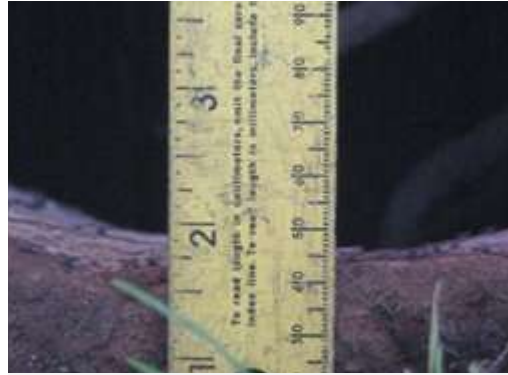
Defect 1

Offset: **1.5** (in.)

frame offset 1.5

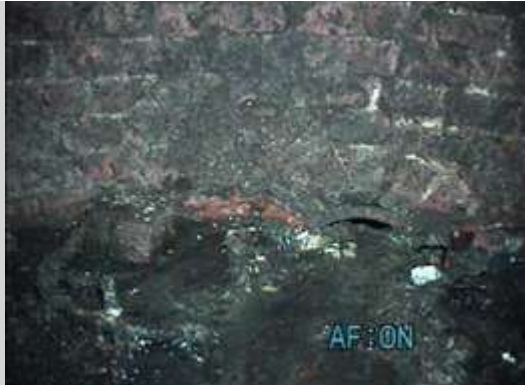
12 O'Clock Outflow

Deposits: ☐ None ☐ Mud ☐ Sludge ☒ Debris ☐ Grease

Silt Depth: 5 (in.) Deposits Extent: Heavy

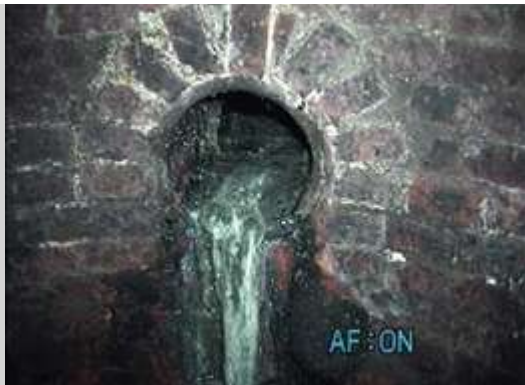
4 O'Clock Inflow

Deposits: ☐ None ☐ Mud ☒ Sludge ☐ Debris ☐ Grease

Silt Depth: 0 (in.) Deposits Extent: Medium

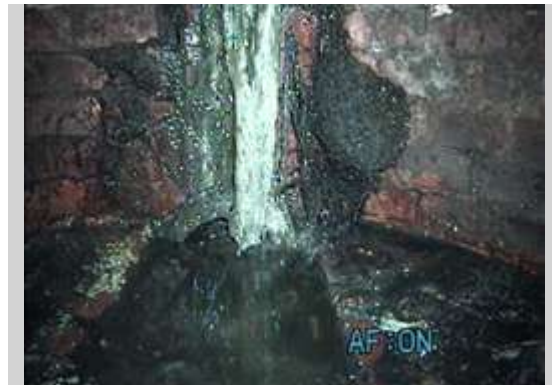
Drop In @ 4 O'Clock

Drop Condition: Clogged

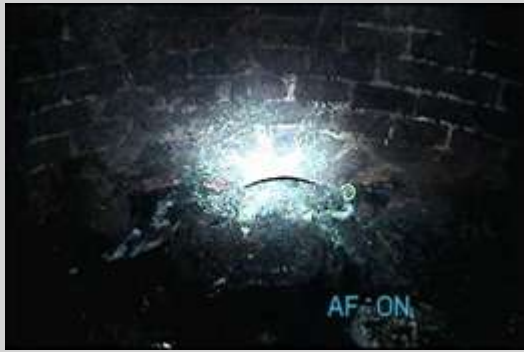
6 O'Clock Inflow

Deposits: ☐ None ☐ Mud ☐ Sludge ☒ **Debris** ☐ Grease

Silt Depth: 6 (in.) Deposits Extent: **Heavy**
